TAS 202 TEST REPORT

Report No.: D7097.01-109-18

AMERIMAX EXTERIOR HOME PRODUCTS Lancaster, Pennsylvania

PRODUCT TYPE: Louver System (Aluminum) **SERIES/MODEL**: Equinox

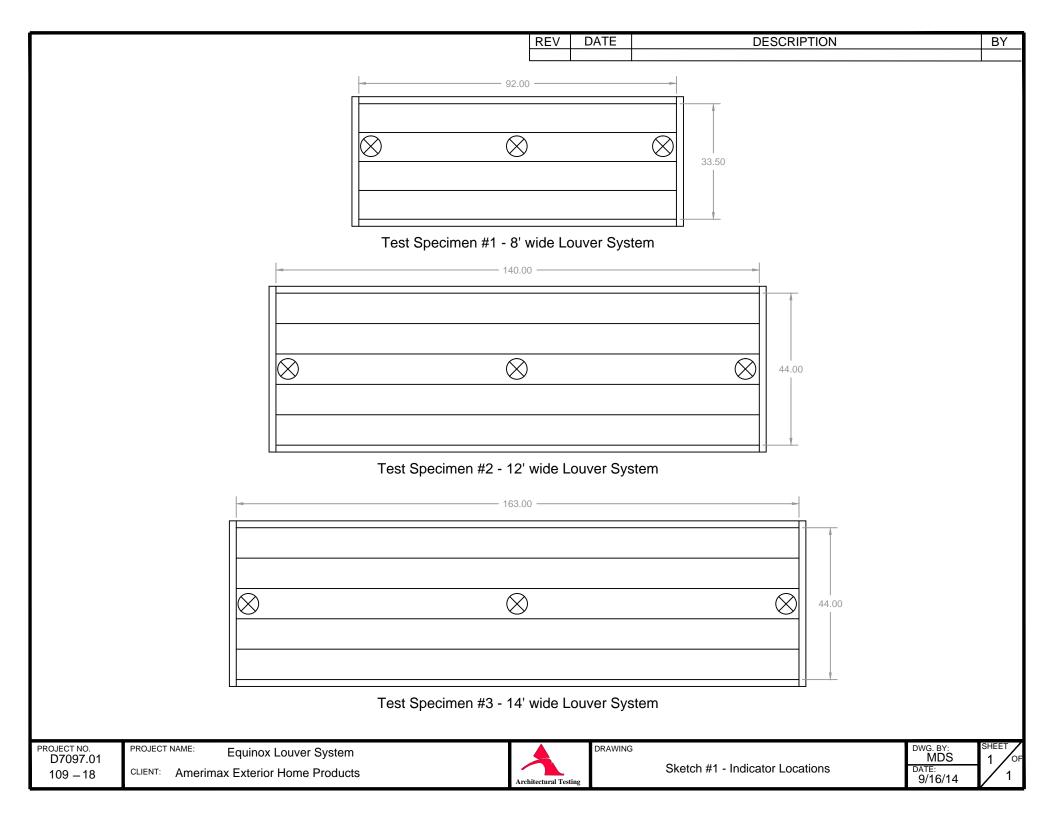
Sketch

Note: See Architectural Testing Sketches #1 and #2 in Appendix C for indicator locations. Deflection/permanent set reported is the overall deflection between three points (longest unsupported span) which accounts for support movement.

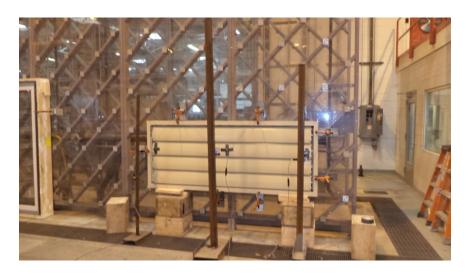
Photo No. 1 8' Unit Set-up for Negative Loads

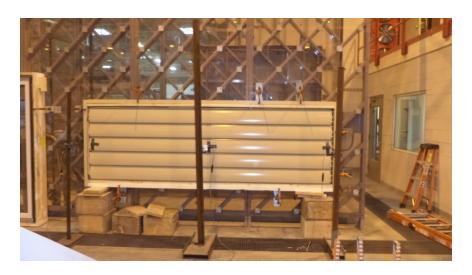
Photo No. 2 12' Unit Set-up for Negative Loads

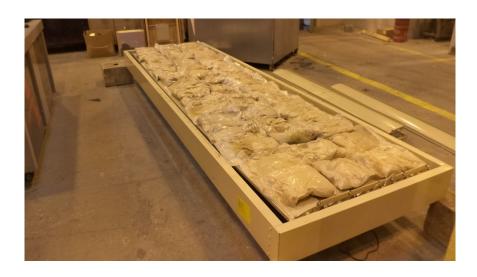
Photo No. 3 14' Unit Set-up for Gravity Load Test

- **7.1 Test Method**: A uniform gravity load was applied to Test Specimen #3 in accordance with the requirements of Florida Building Code 2010, Chapter 16. The gravity load test was applied to the specimen by applying 10 lb sand bags uniformly over the surface of the test specimen. A 10 psf gravity load was applied to the specimen, which was based on the Code that required a gravity load of 5 psf and a 2.0 safety factor. The 10 psf gravity load was applied to the specimen via the sand bags and maintained on the specimen for a period of 24 hours. At the completion of the 24 hour test, the sand bags were removed and the specimen was inspected for any signs of damage.

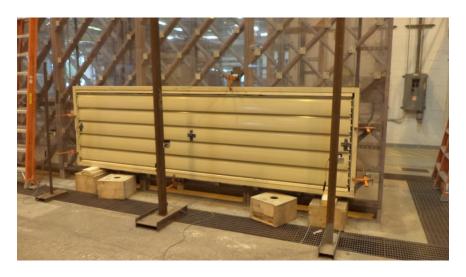
Photo No. 4 14' Unit Set-up for Negative Loads

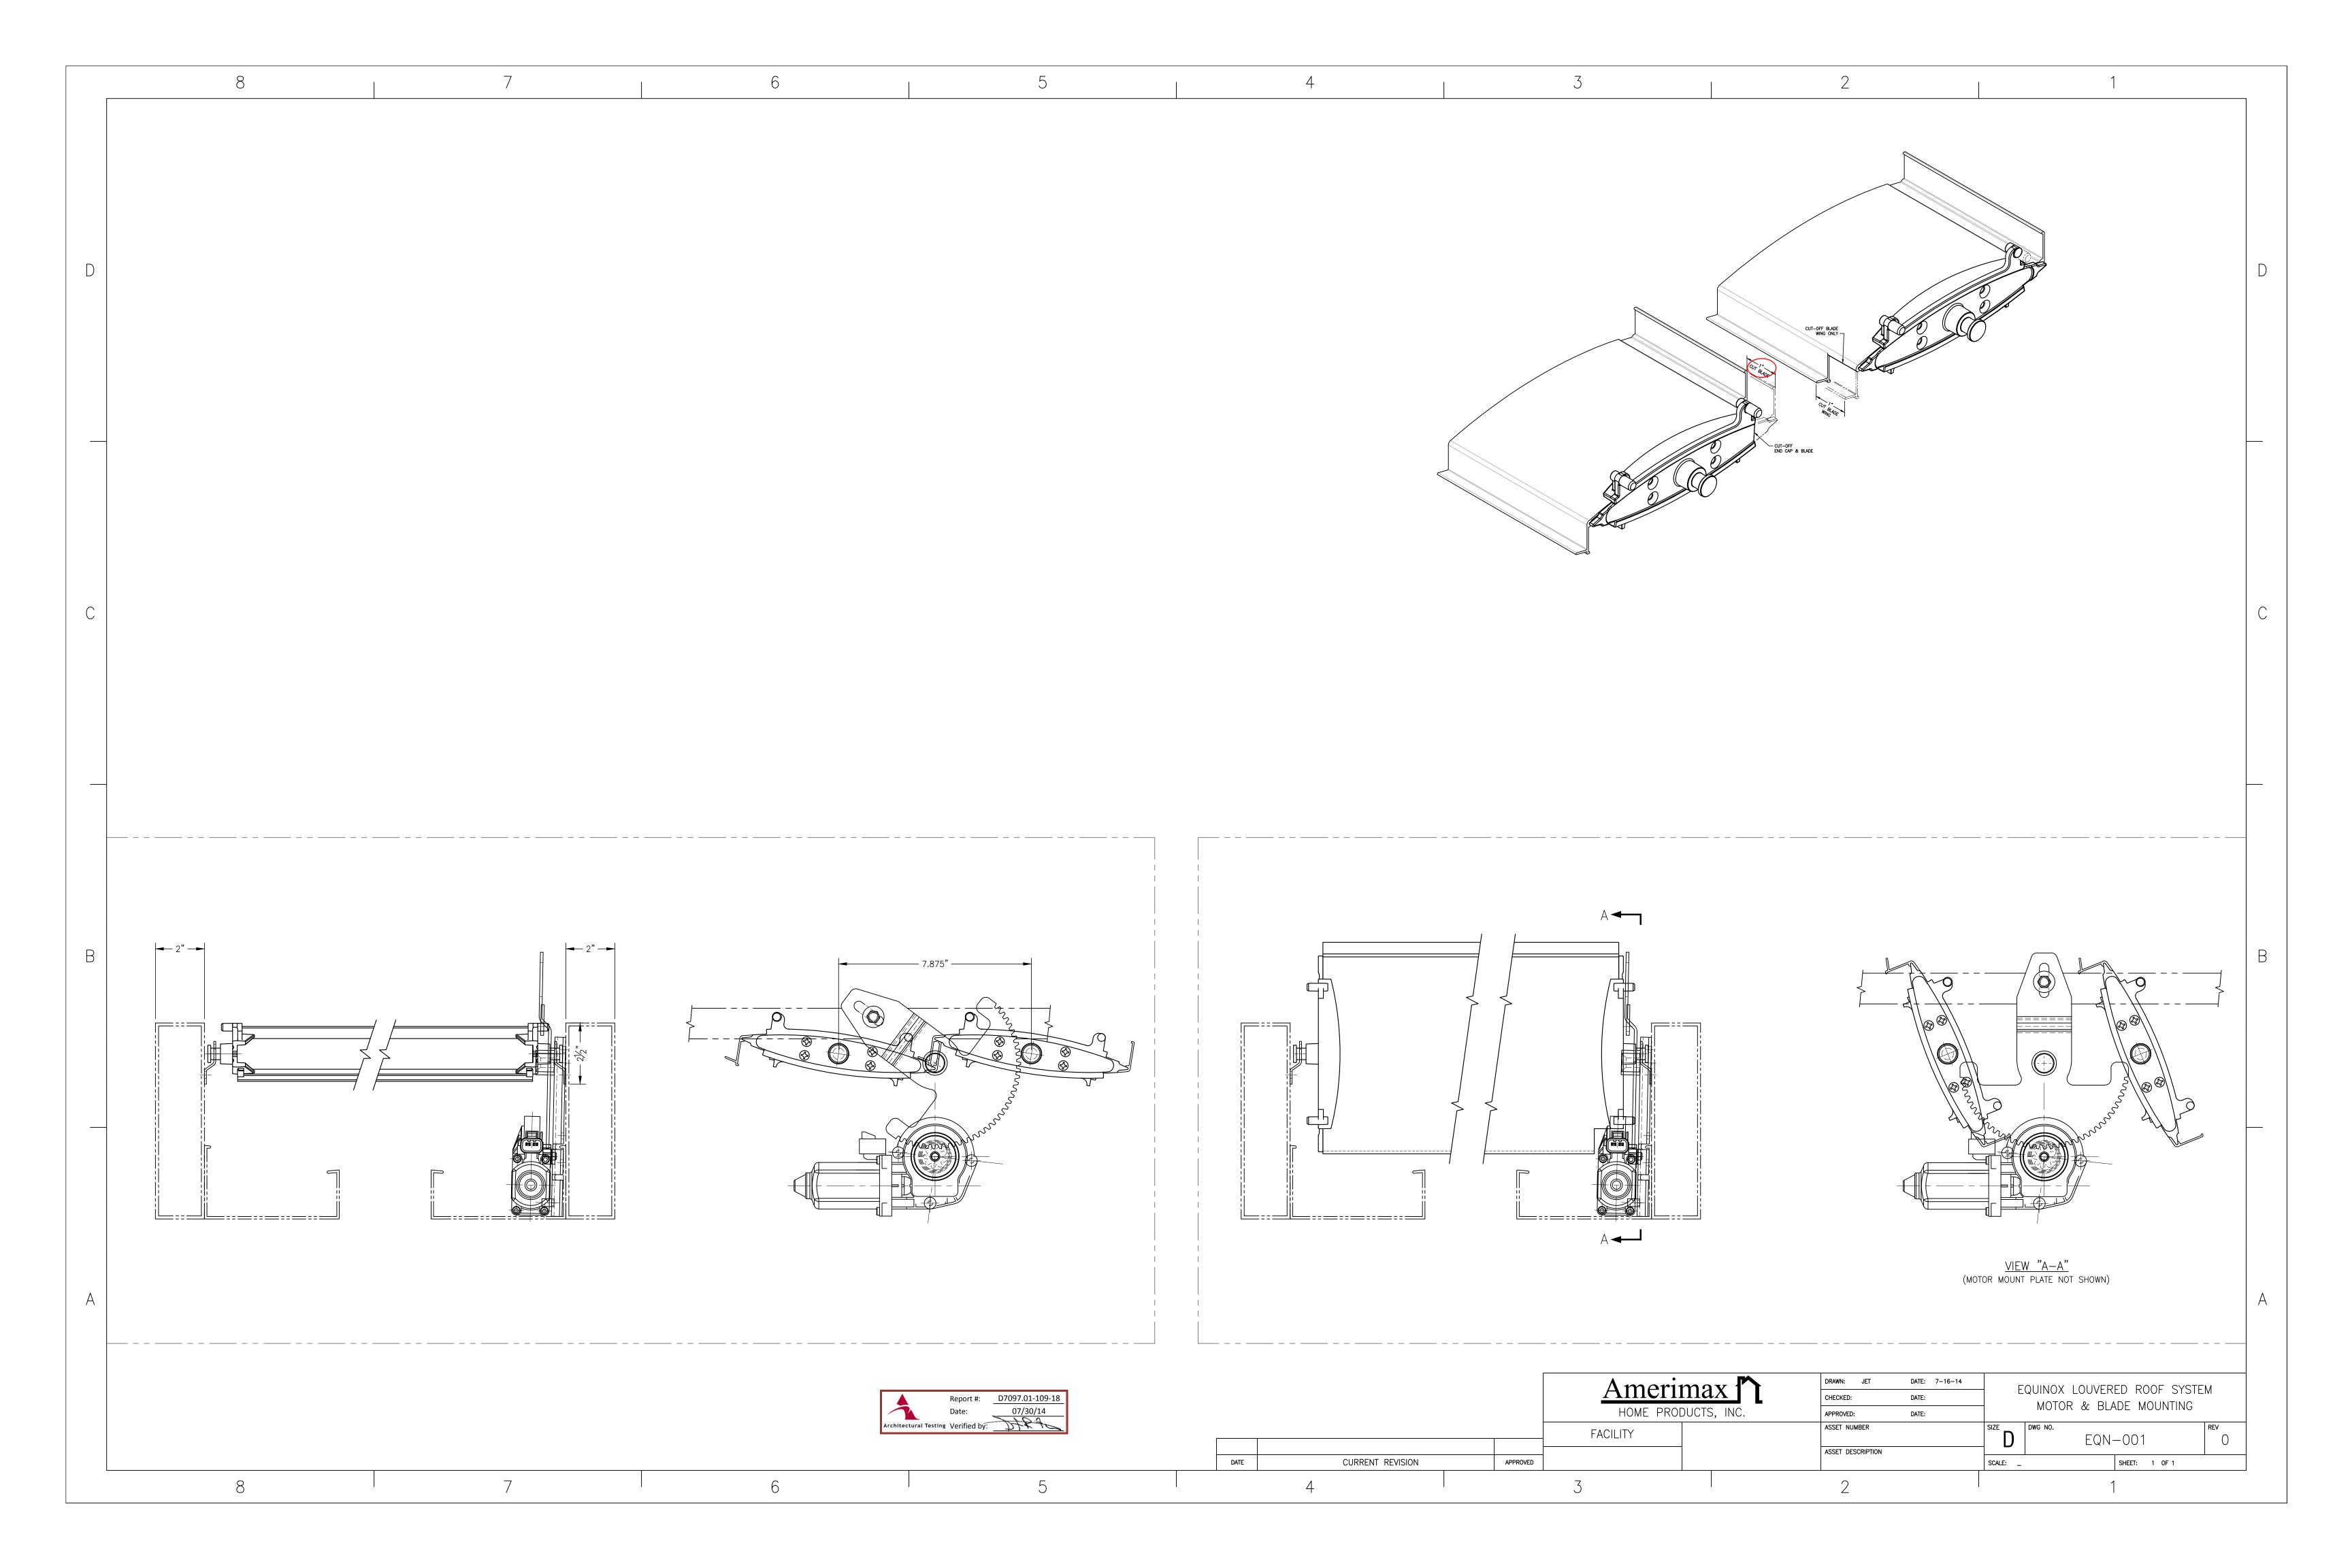
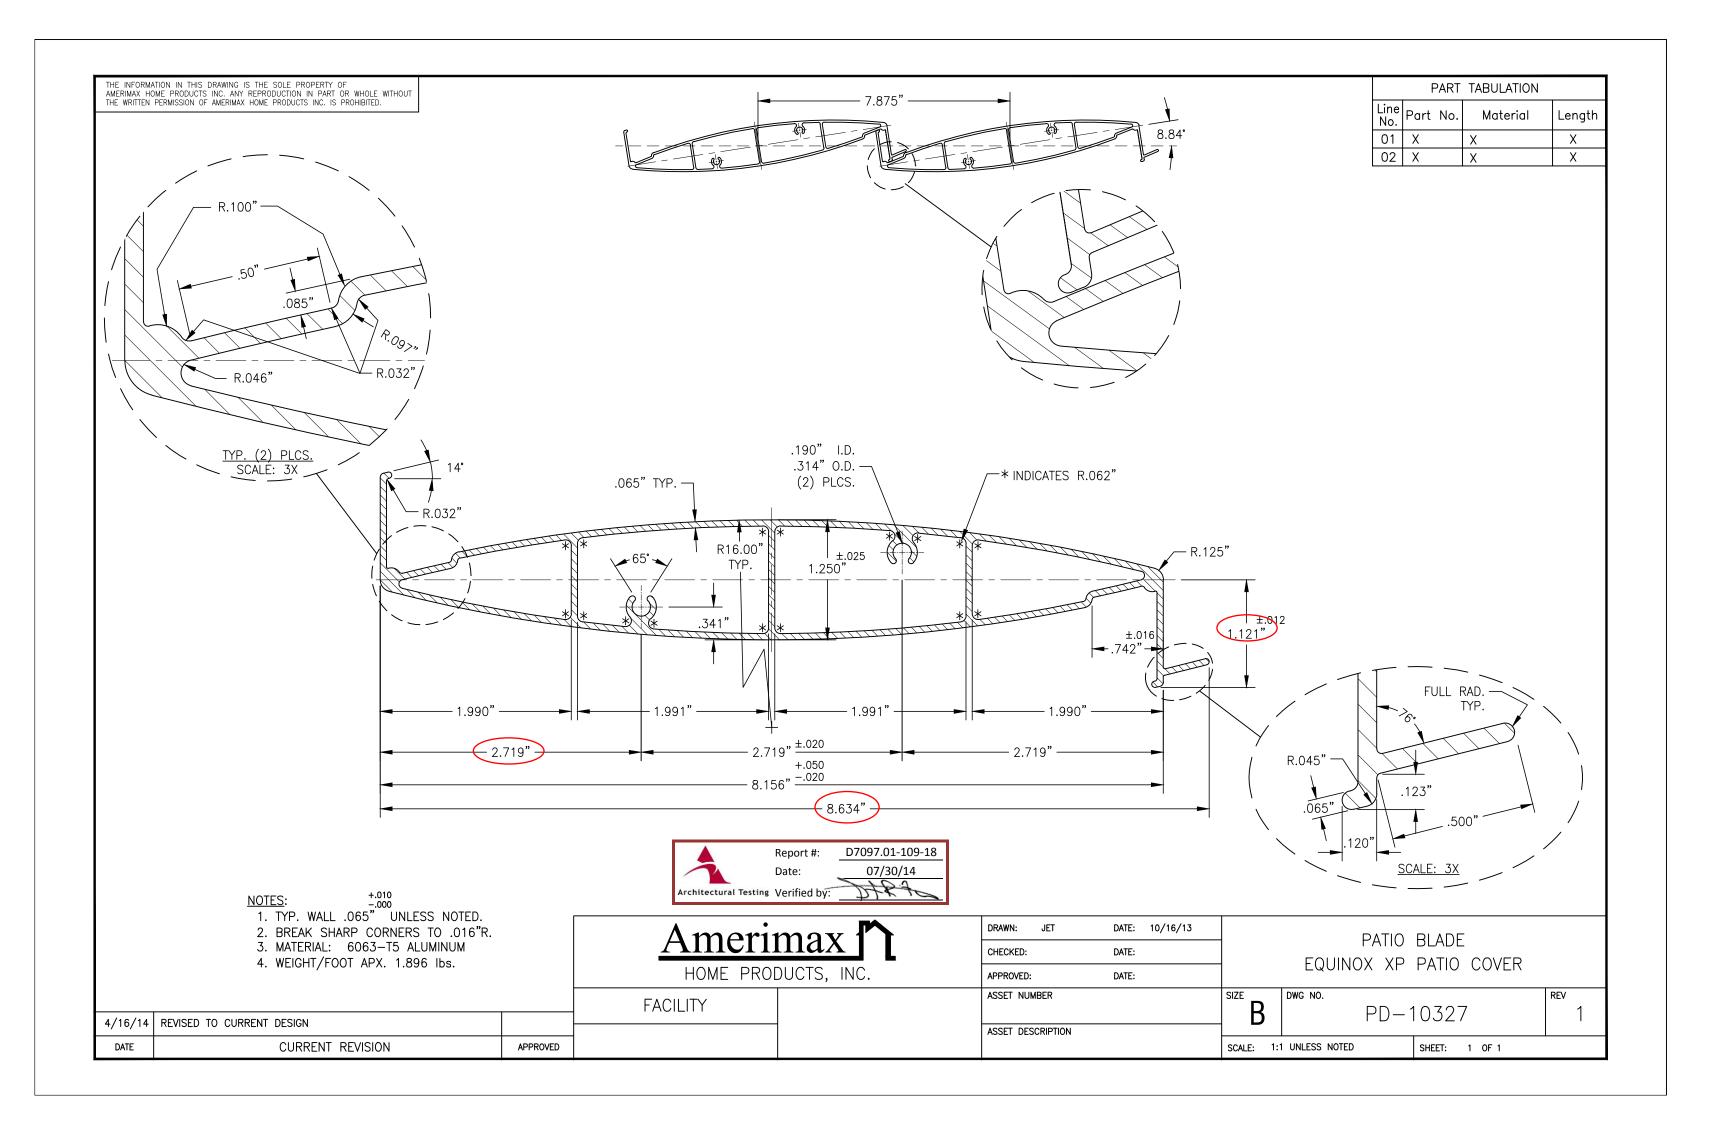
DETAIL F1 EXTRUDED 6063T5 ALUMINUM LOUVER

DETAIL F2 2"x8" EQUINOX HEADER AND RETURN BEAM

DETAIL F3
EQUINOX LOUVER
MOUNTING RAIL
0.100" 6005A-T5 ALUM

DETAIL F4
EQUINOX LOUVER TO MOUNTING
RAIL TO HEADER CONNECTION

- **5.3 Frame Description**: The louver system utilized a four piece aluminum box beam, (Reference Detail F2, Drawing #EquinoxPlansFBC_FPA.dwg) frame. An aluminum beam clip was secured to the side beams with four #14 x 3/4" self-drilling screws. The end beams were notched then slipped over the beam clip and secured to the beam clip with eight #14 x 3/4" self-drilling screws, (four on the interior and four on the exterior).

- **5.4 Assembly Description**: Aluminum pivot strips, (Reference Detail F3, Drawing #EquinoxPlansFBC_FPA.dwg) were secured to the side frame beam with #14 x 3/4" self-drilling screws, spaced 8" on center. An electric operator motor assembly was attached to the center of the side frame beams with four #14 x 3/4" self-drilling screws. Aluminum louvers with end caps were set into the pivot strips and connected with an aluminum link bar. The link bar was secured to the louver end caps with a push-on retainer washer at each louver. The operator motor was secured to the link bar with one 5/16" x 1" bolt with washers and lock nut.

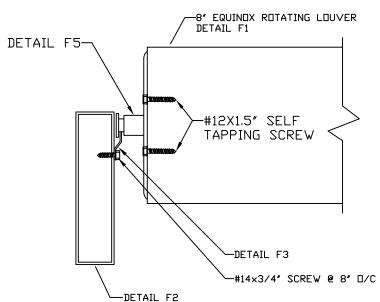
DETAIL F5 CAST ALUMINUM A380 END CAP

- **5.2 Louver Blade Description**: The louver blades were constructed from extruded aluminum. The end of each blade utilized a cast aluminum end cap, secured to the blade with two $#12 \times 1-1/4$ " long flat head screws.

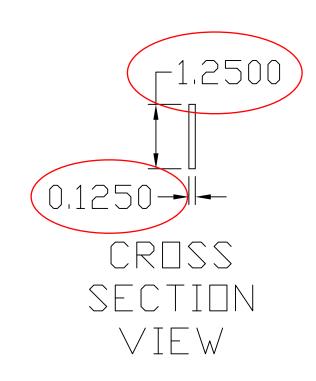
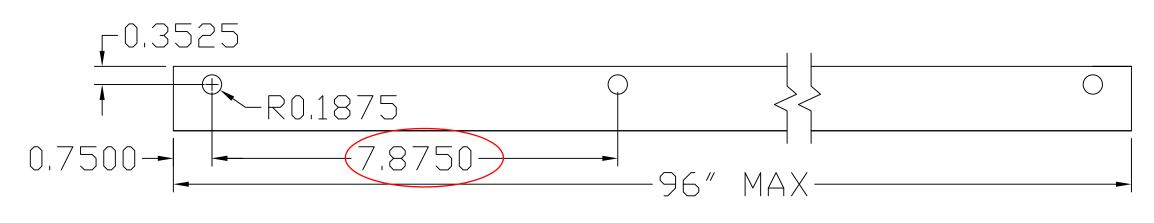
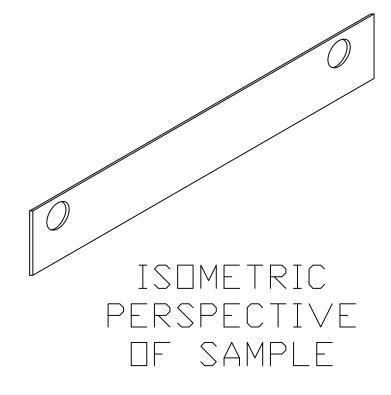
EQUINOX LINK BAR

- 1. ALL DIMENSIONS ARE IN INCHES.
- 2. MATERIAL: 6061T6 ALUMINUM
